V92-FC+™ CELLULAR BONE CASE SERIES

***FEATURED PRODUCTS: V92-FC+™ Cellular Bone Matrix,
Monster® Hindfoot Screw System, Gorilla® Calc Fracture Plating System,
Phantom® ActivCore Nail System, Gorilla® Universal Plating System***

Surgeon Author: Michael Gentile, DPM
Practice: Marshall University School of Medicine, Huntington, WV
Faculty: Marshall University School of Medicine, Huntington, WV

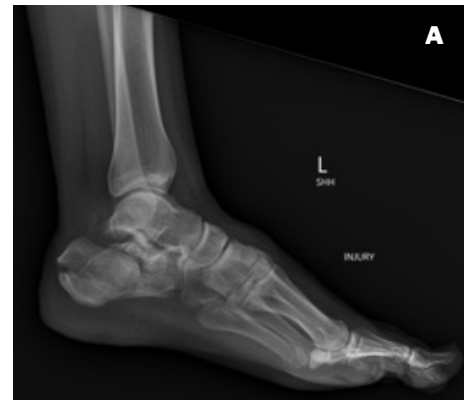
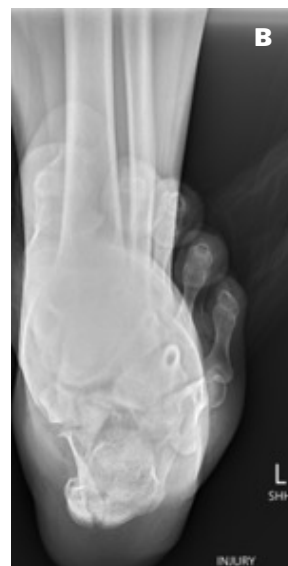
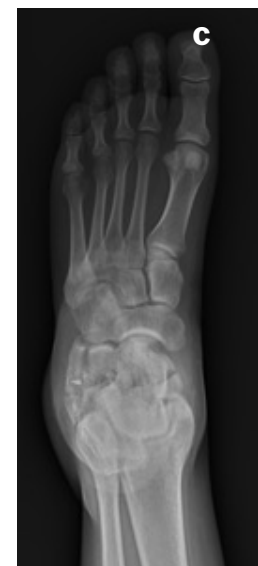
Figure 1 (A–C): Injury films. **A.** NWB lateral view shows displaced, comminuted, joint depression calcaneal fracture with a tongue variant. **B.** NWB axial view shows comminuted tuberosity with lateral wall expansion. **C.** NWB AP foot view shows extension into calcaneal cuboid joint and lateral wall expansion

X-ray (Figure 1 (A–C)) and CT scan (Figure 2 (A–C)) showed a Sanders IV joint depression fracture. There was significant comminution involving the lateral wall blowout, varus in shortening of the calcaneal tuber as well as fracturing of the sustentaculum. The sustentaculum appeared to be in a constant position. There were not any other obvious fractures or dislocations.

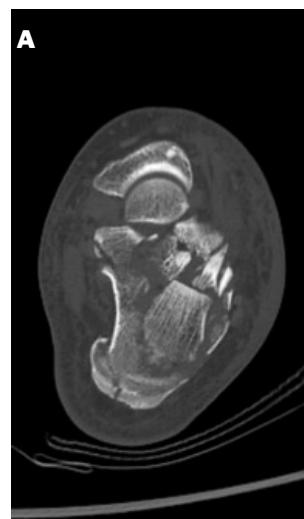
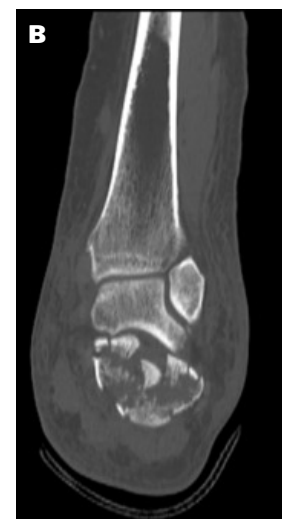
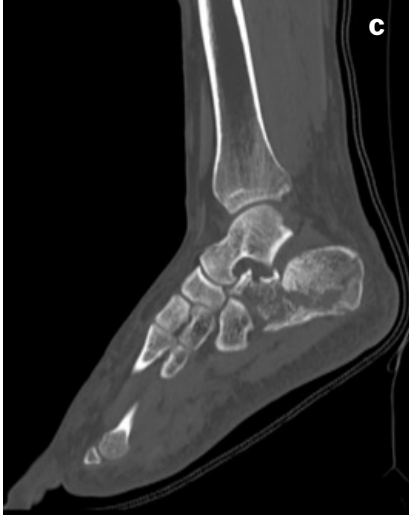
Figure 2 (A-C): CT Scan of fracture. **A.** Axial view depicting severe comminution of the posterior facet of the subtalar joint and lateral wall blowout. **B.** Coronal view **C.** Lateral view.

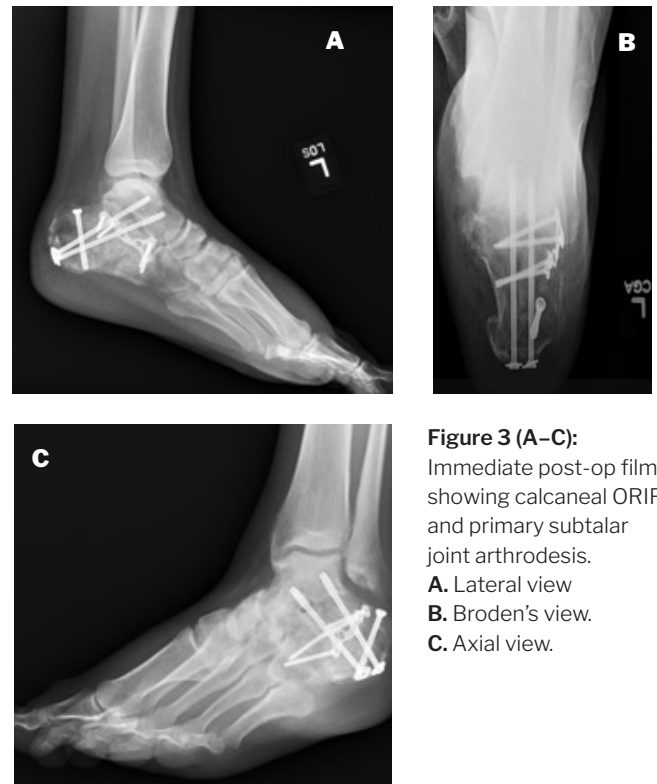
Figure 3 (A-C): Immediate post-op films showing calcaneal ORIF and primary subtalar joint arthrodesis. **A.** Lateral view **B.** Broden's view. **C.** Axial view.

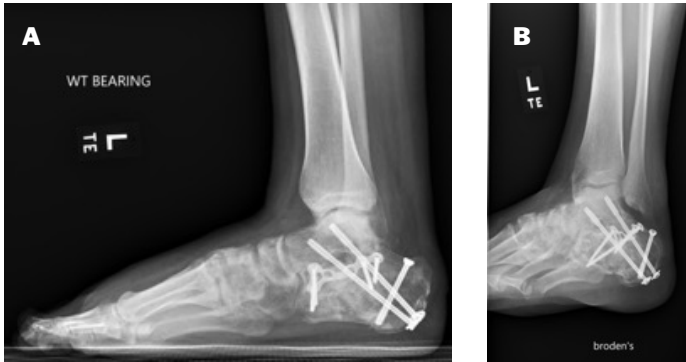
Figure 4 (A-B): X-rays at 3 months post op. Evidence of trabeculation across the subtalar joint and consolidation of calcaneal fracture. Note maintenance of normal talar sagittal plane alignment. **A.** Lateral view. **B.** Broden's view

At 12 weeks, radiographic signs of healing across the subtalar joint were shown and the patient reported decreasing pain at the fusion site. There was radiographic evidence of trabeculation across the subtalar joint and consolidation of the calcaneal fracture with normal sagittal plane alignment. (Figure 4 A-B). The patient was seen again at 5 months and radiographs demonstrated maturation of the subtalar arthrodesis with maintenance of alignment (Figure 5 A-C). The ostia of the fracture appeared to have healed well as alignment appeared to be near anatomic with a normalized Bohler's angle. The avulsion fracture showed healing and there was no arthritis at the calcaneocuboid joint.

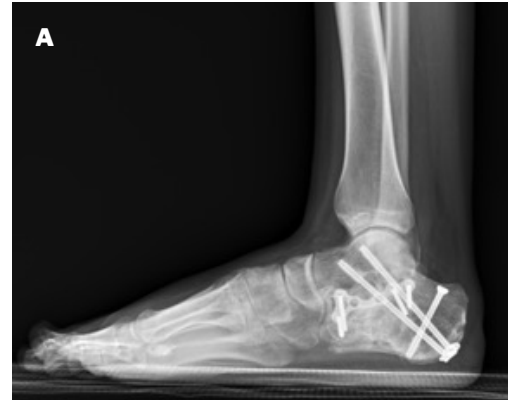
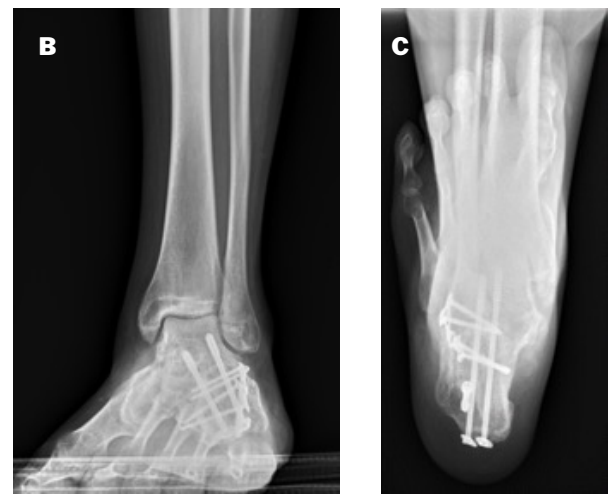
Figure 6 (A-C): X-rays at 10.5 months post-op depicting maturation of the subtalar arthrodesis with maintenance of alignment. **A.** Lateral view. **B.** Broden's view. **C.** Axial view.

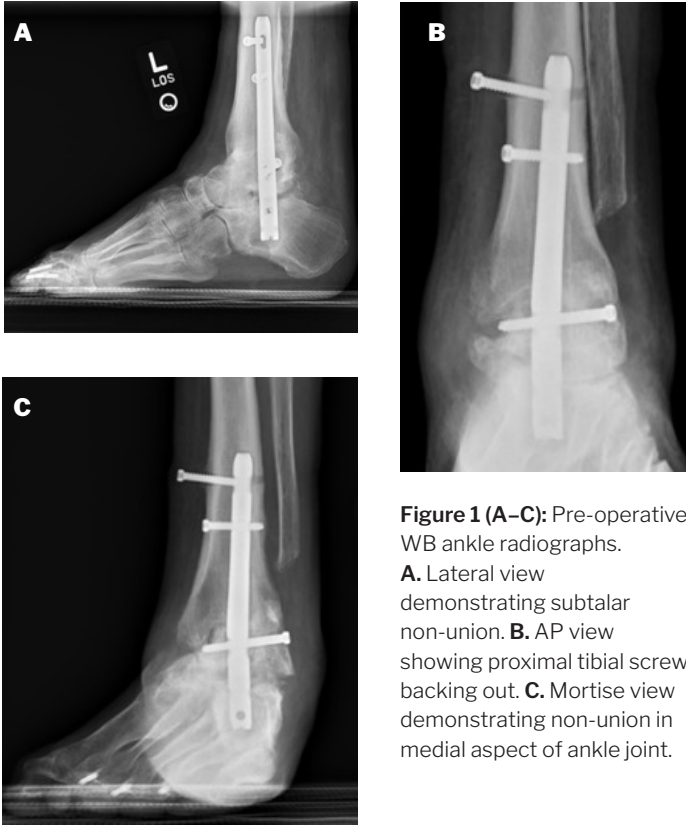
Figure 1 (A-C): Pre-operative WB ankle radiographs.

A. Lateral view demonstrating subtalar non-union. **B.** AP view showing proximal tibial screw backing out. **C.** Mortise view demonstrating non-union in medial aspect of ankle joint.

a septic non-union work up was undertaken. The patient had normal serologic markers. The radiographs showed subtalar and ankle joint non-union with an equinus malunion. AP and lateral view of the hindfoot showed viability of the talus and abnormal but present medial malleolus. It was confirmed that the nonunion of the ankle and subtalar joints was with associated hardware failure (Figure 1 (A-C)). The patient was counseled on available options and agreed to a revision TTC fusion, tibial osteotomy, and posterior tibial tendon release.

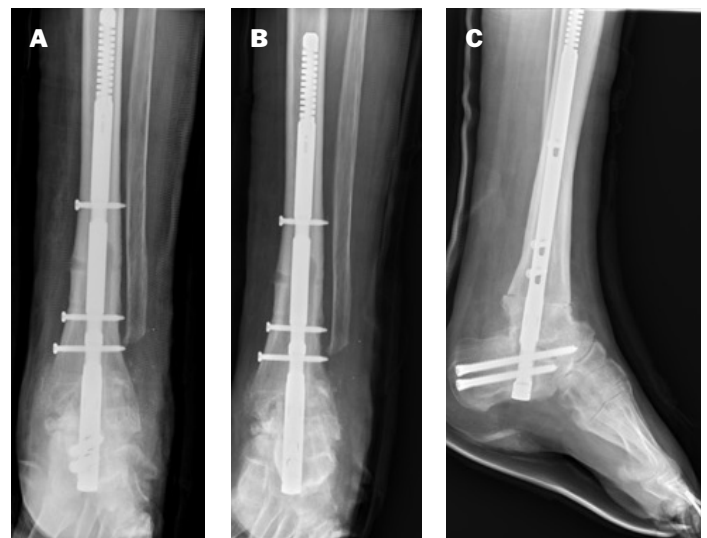
Figure 2 (A-C): Three NWB ankle radiographs post-op week two showing TTC fusion with tibial osteotomy. **A.** AP view **B.** Mortise view **C.** Lateral view

The patient returned to clinic at two weeks and three non-weight bearing view of the ankle were taken showing coaptation of both the subtalar and ankle joint fusion sites (Figure 2 (A-C)). The distal tibial osteotomy showed excellent opposition and the nail remained countersunk below the level of the calcaneus. Stiches were removed and the patient was placed into a below-knee non-weight-bearing cast. The patient returned at nine weeks and reported that the patient had been ambulatory in his fracture boot with very little pain. Three weight-bearing views of the ankle as well as the tib-fib and foot films were captured. The radiographs demonstrated continued consolidation at the tibial osteotomy and progression of bony fusion across the subtalar joint (Figure 3 (A-C)). There were no signs of hardware loosening and/or stress around the implant. Rocker bottom shoes were recommended for the patient and a follow-up visit was scheduled for two months. The patient returned to clinic at five months post-op and weight-bearing films were captured demonstrating continued bone formation and no sign of stress around any of the hardware (Figure 4 (A-C)). Bony bridging across the anterior surface of the subtalar joint was more mature than posteriorly and the patient reported improved pain and increased activity. The patient was asked to return in six months. The patient returned at one-year post-op and weightbearing views of the ankle and tib-fib were taken showing continued consolidation along the ankle joint. There was some questionable joint lucency at the subtalar joint itself with no signs of nail loosening. The patient reported pain and activity had improved since the previous visit and the patient was advised to continue to schedule

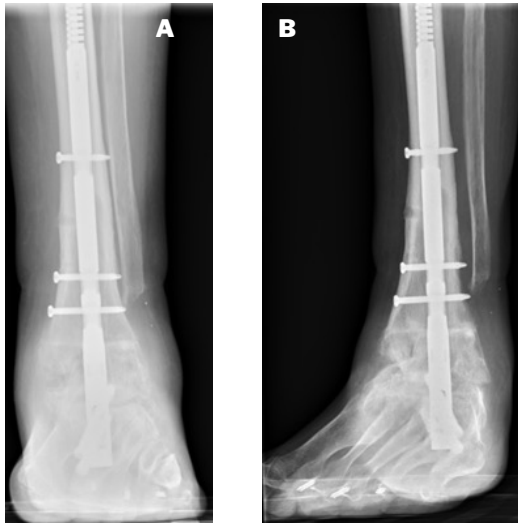
Figure 3 (A-C): Three WB ankle radiographs 3 months post op showing signs of fusion across the ankle and subtalar joints and union of the tibial osteotomy. **A.** AP view **B.** Mortise view **C.** Lateral view

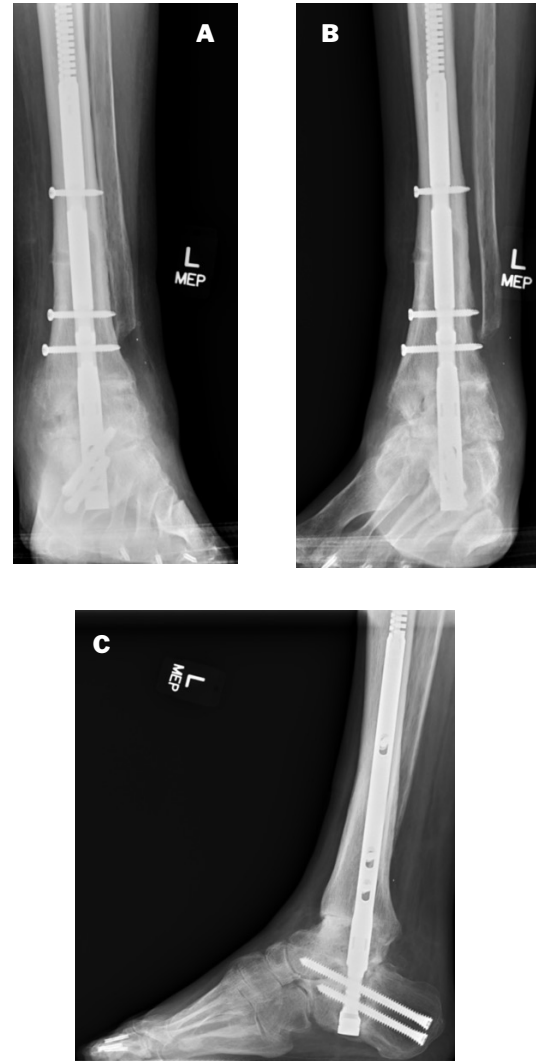
Figure 4 (A-C): Three WB ankle radiographs 5 months post op showing maturing signs of fusion across the ankle and subtalar joints and union of the tibial osteotomy. **A.** AP view **B.** Mortise view **C.** Lateral view

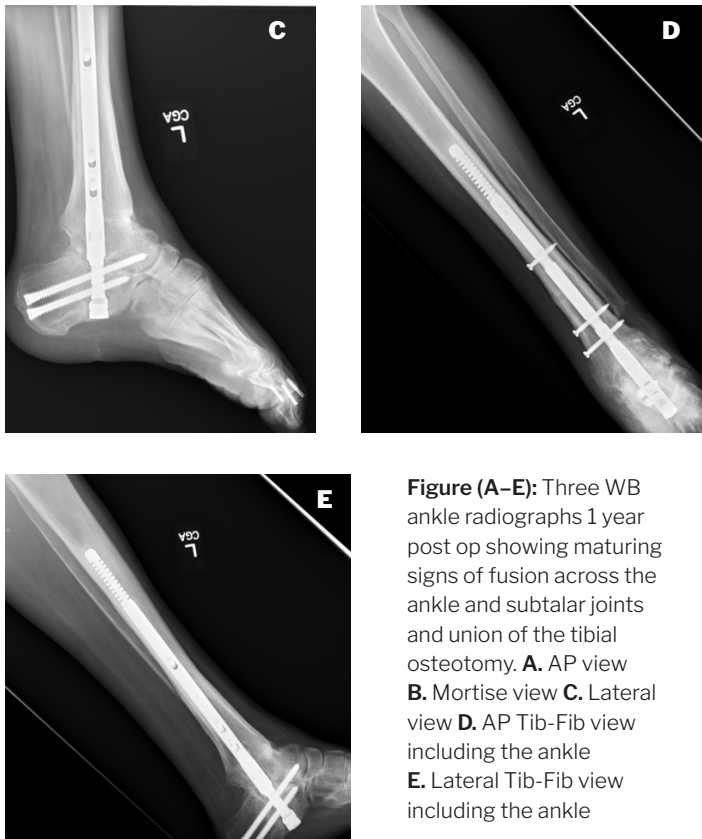
Figure (A-E): Three WB ankle radiographs 1 year post op showing maturing signs of fusion across the ankle and subtalar joints and union of the tibial osteotomy. **A.** AP view **B.** Mortise view **C.** Lateral view **D.** AP Tib-Fib view including the ankle **E.** Lateral Tib-Fib view including the ankle

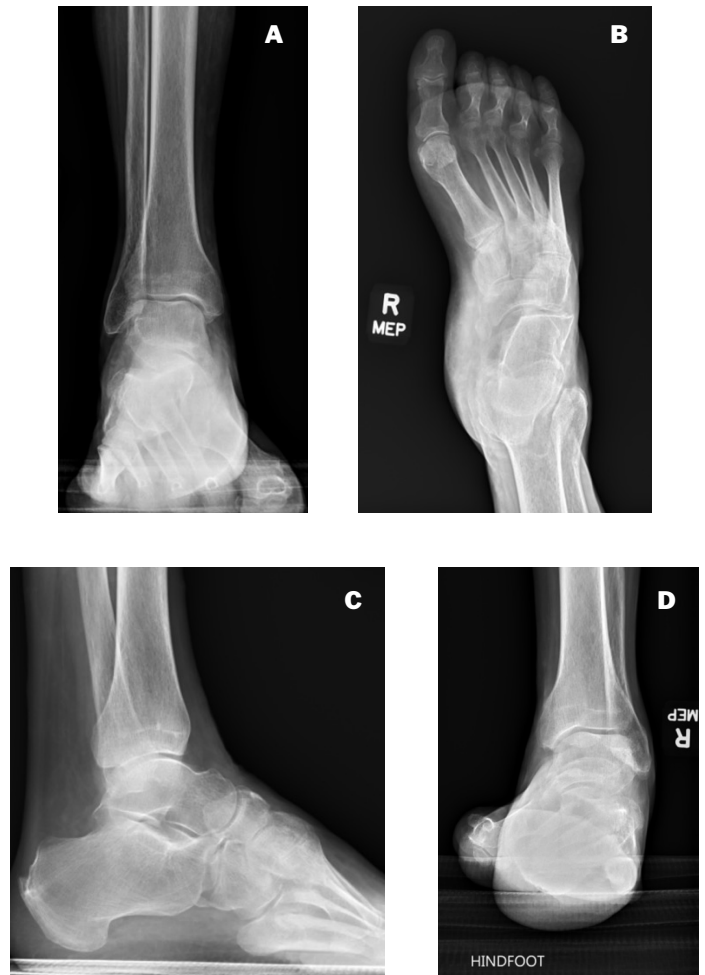
Figure 1 (A-D): Pre-operative WB films. **A.** Ankle AP showing normal ankle alignment. **B.** Foot AP showing adductovarus deformity of rearfoot and midfoot. **C.** Ankle/Foot Lateral showing cavus sagittal plane alignment. **D.** Hindfoot alignment view showing rearfoot varus deformity

A 69-year-old with syringomyelia presented with semi-reducible progressive equinovarus deformity of both lower extremities. Weight-bearing views of the right foot and ankle demonstrated significant sagittal plane cavus with the apex of the deformity at the level of the talonavicular joint with a relative normally aligned ankle (Figure 1 (A-C)). The patient had failed multiple attempts at bracing and desired surgical intervention. The surgical plan included an Achilles tendon lengthening, Steindler stripping, triple arthrodesis with osteotomy, posterior tibial tendon transfer and a dorsiflexion wedge osteotomy of the 1st metatarsal.

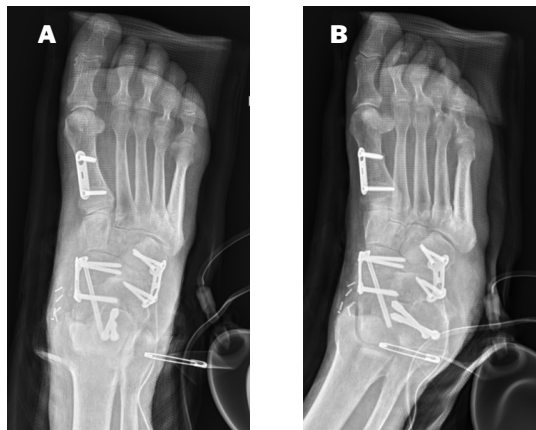
Figure 2 (A-C): Three NWB ankle radiographs post-op week 1 showing TTC fusion with tibial osteotomy.
A. AP view
B. Mortise view
C. Lateral view

X-Rays were collected at one-week post-operative showing maintenance of alignment (Figure 2 (A-C)). The patient returned a week later, and all incisions were clean, dry, and intact. All stitches were removed, and the patient was able to wiggle his toes and his sensation was at baseline. There was no tenderness along the calf or lower leg. The patient was converted to a cast and was asked to return in two weeks for a cast change and again in four weeks for additional non-weight-bearing x-rays of the right foot and ankle. The patient returned at three months post-surgery and weightbearing radiographs

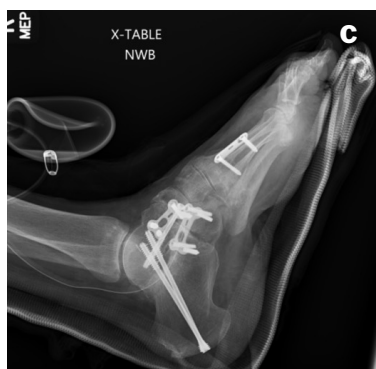
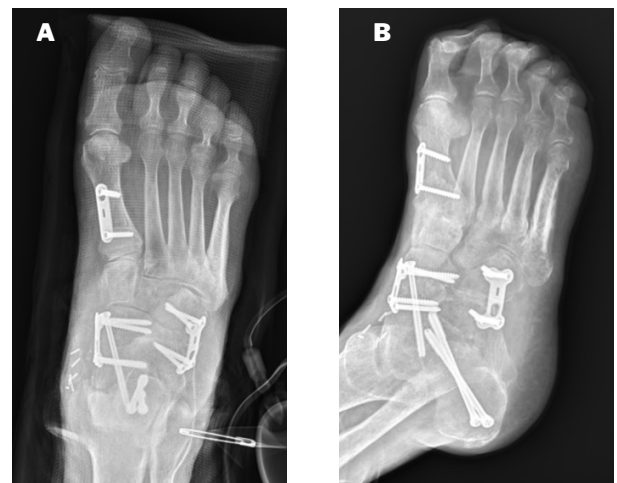
Figure 3 (A-C): Three WB ankle radiographs 3 months post-op showing signs of fusion across the ankle and subtalar joints and union of the tibial osteotomy.
A. AP view
B. Mortise view
C. Lateral view

of the right foot were taken showing good interval signs of fusion across the entirety of the fusion construct with stable hardware (Figure 3 (A-C)). His forefoot and midfoot alignment have improved significantly compared with preoperative films and the dorsiflexory wedge of the 1st metatarsal has consolidated. Meary's angle is nearly back to normal and there is a lucency in the intermediate cuneiform consistent with the tendon transfer. Continued maturation of the fusion site radiographically continued with absence of pain at the fusion site clinically. Normal alignment parameters were maintained at subsequent visits. At 14 months, radiographs were obtained demonstrating a solid arthrodesis through the entirety of the hindfoot with stable hardware throughout with evidence of a healed 1st metatarsal osteotomy (Figure 4 (A-C)). There were no signs of degeneration within the ankle and there is still a well-rounded lucency in the central cuneiform consistent with tendon transfer on his standing films. The dropfoot has done remarkably well and the patient is walking with a heel to toe progression.

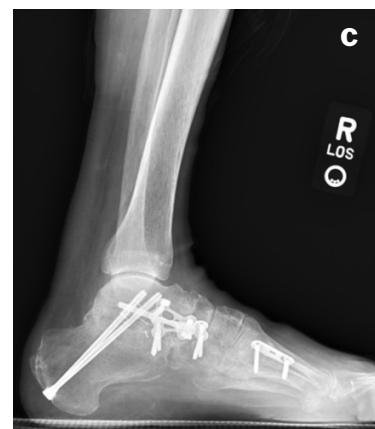
Figure 4 (A–C): WB X-rays at 14 months post op showing solid trabeculation across all 3 of the arthrodesis sights and the 1st metatarsal osteotomy. **A.** AP view **B.** Medial oblique view **C.** Lateral view
